**CITY OF ROCKVILLE HISTORIC DISTRICT COMMISSION
STAFF REPORT**

**December 16, 2010
Meeting No. 15-10**

APPLICATION: HDC2011-00523
ADDRESS: 300 W Montgomery Ave
ACCEPTED: 11/8/10
45 DAY LIMIT: 12/30/10
OWNER: Mr. Will Pumphrey
REQUEST: Replace existing pressboard siding with HardiPlank
STAFF: Robin D. Ziek

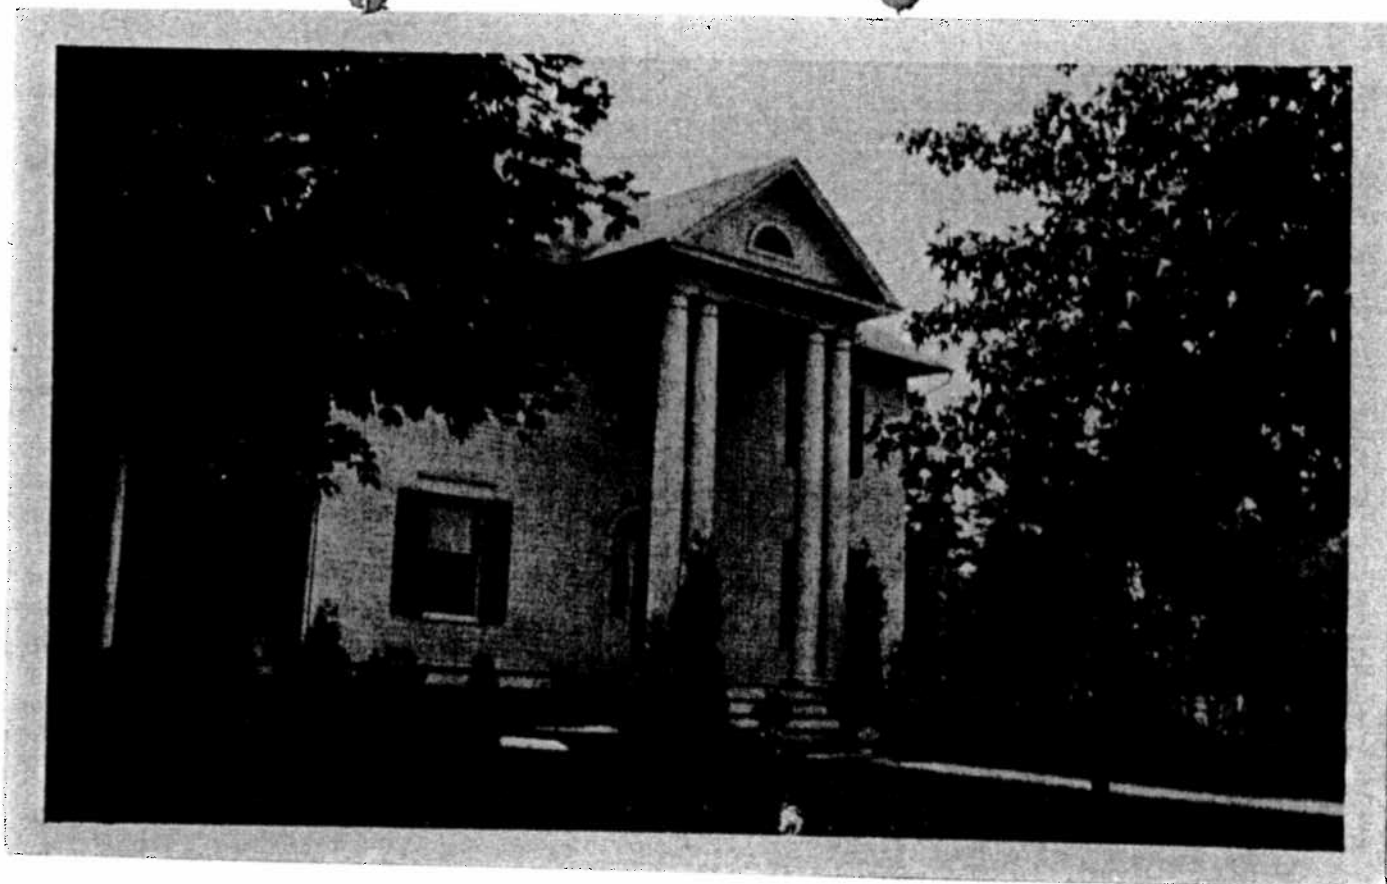
1930 photo. From 1984 Peerless Rockville calendar M: 26/10/35
Pumphrey's Funeral Home, 300 West Montgomery Ave.

The applicant provided a copy of an old photograph with sufficient detail to count the horizontal siding boards in relation to a front window (see Circle 4). That photograph indicates that the siding had a narrower dimension than is currently on the house. Another early photograph [a 1930s view depicted on a calendar produced by Peerless Rockville] indicates narrow lapped siding, as evidenced by the shadow lines (see Circle 5). Horizontal lapped wood siding would be typical siding material in the late 19th and early 20th century, with the potential for shingles or some siding variant in the gable ends.
